Contract #: 04-0120F4Cty: SF/ALA Rte: 80 PM: 13.2/13.9File #: 69.28**WELDING INSPECTION REPORT****Resident Engineer:** Pursell, Gary**Address:** 333 Burma Road**City:** Oakland, CA 94607**Report No:** WIR-013018**Date Inspected:** 04-Apr-2010**Project Name:** SAS Superstructure**OSM Arrival Time:** 1900**Prime Contractor:** American Bridge/Fluor Enterprises, a JV**OSM Departure Time:** 700**Contractor:** Zhenhua Port Machinery Company, Ltd (ZPMC), Changxing Island **Location:** Shanghai, China**CWI Name:** See Below**CWI Present:** Yes No**Inspected CWI report:** Yes No N/A**Rod Oven in Use:** Yes No N/A**Electrode to specification:** Yes No N/A**Weld Procedures Followed:** Yes No N/A**Qualified Welders:** Yes No N/A**Verified Joint Fit-up:** Yes No N/A**Approved Drawings:** Yes No N/A**Approved WPS:** Yes No N/A**Delayed / Cancelled:** Yes No N/A**Bridge No:** 34-0006**Component:** OBG**Summary of Items Observed:**

On this date CALTRANS OSM Quality Assurance (QA) Inspector, Mr. Paul Dawson, arrived on site at the Zhenhua Port Machinery Company (ZPMC) facility at Changxing Island, in Shanghai, China, for the purpose of monitoring welding and fabrication of the San Francisco / Oakl

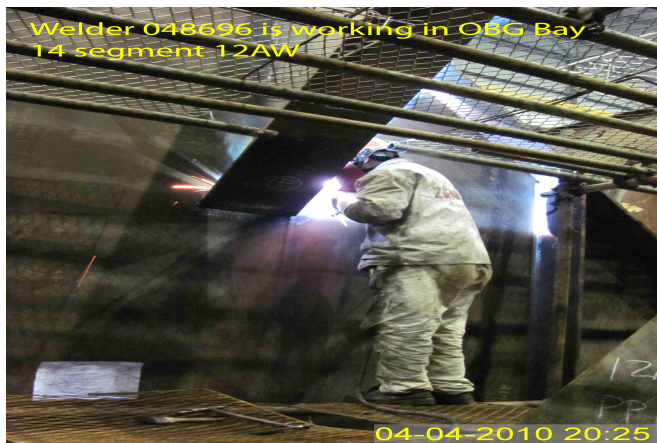
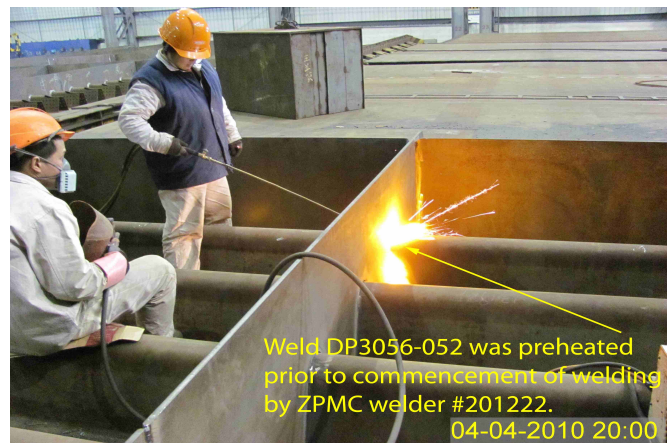
This QA Inspector observed ZPMC welder Mr. He Hanbi, stencil 201222 is using flux cored welding procedure WPS-B-T-2132 to make OBG segment 12AW weld DP3056-052. This QA Inspector observed a welding current of 310 amps and 32.4 volts and ZPMC CWI Mr. Liu Hua Jie has recorded a welding current of 307 amps and 31.5 volts. This QA Inspector observed the base material was preheated prior to welding and that Mr. He Hanbi appears to be certified to make this weld and the base material has been preheated prior to welding. Items observed on this date appeared to generally comply with applicable contract documents. See the photograph below for additional information.
